## Place No. 29 Mallina Station

Mallina Station homestead group buildings 2012

LOCATION	
Name of Place	Mallina Station
Other Name (1)	McCroy Station (1970s)
Other Name (2)	Milina Homestead and Kitchen
Location/Address	
Street Number	
Street Name	Off North West Coastal Highway
Suburb/Town	Shire of Roebourne
Other Locational descriptor (text)	13 km east of Whim Creek (105 km east of Roebourne), 52 km south of Port Headland mE 607150 mN 7690554 Longitude: 118.0301 Latitude: -20.8821

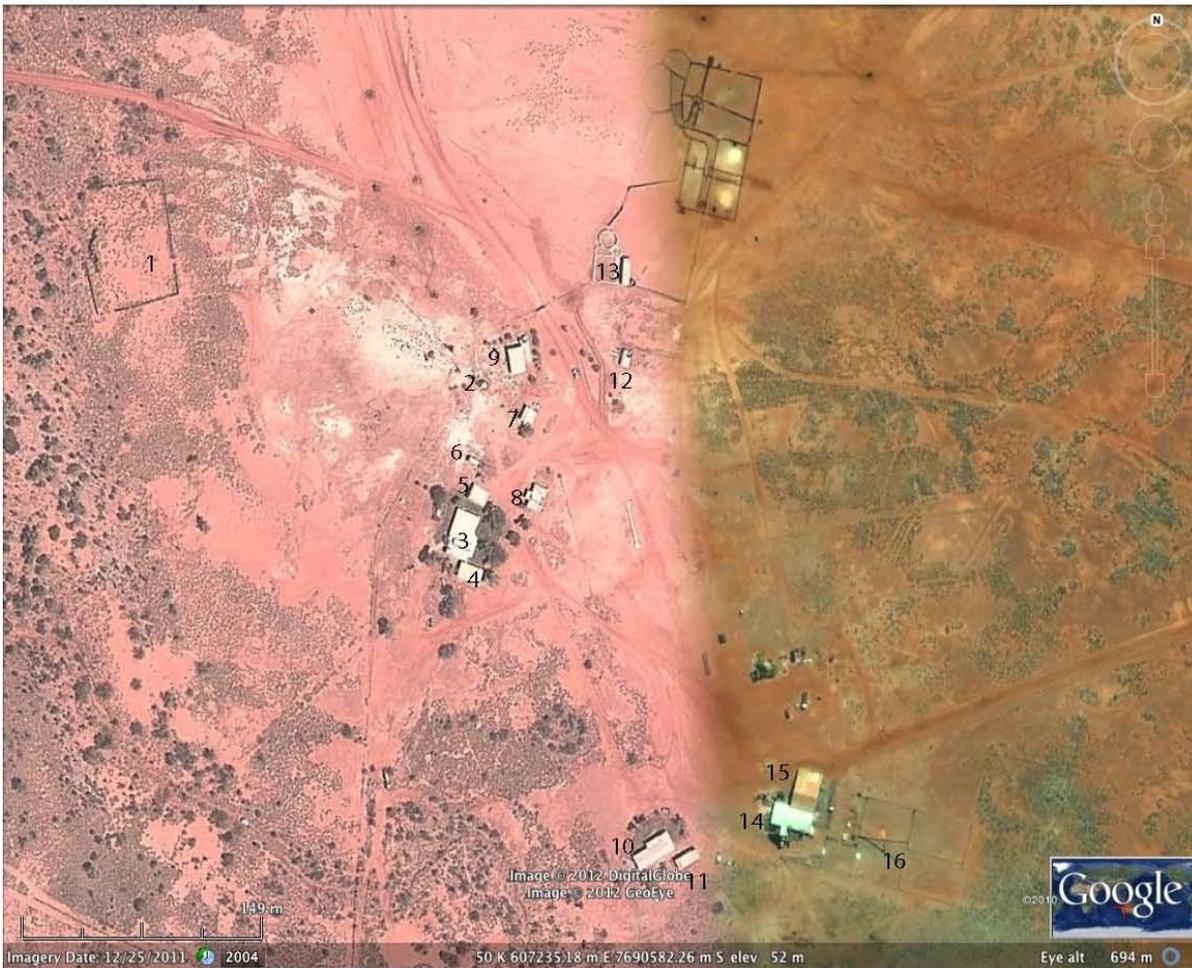
### MALLINA HEAD STATION

1. Holding yards
2. Tank and windmill (modern poly tank in metal tank) at site of white rock outcrop
3. Homestead (Roof structure: CI roof [1980s]; massive steel posts and roof beam running N-S; earlier central CI roof running E-W. Original house concrete walls with original CI roof; concrete and tiles floors. Breezeway at S between central part of house and demountable.)

4. Residence: Late 20th century structure (metal roof, fibro panel walls)
5. Cookhouse, mess and original store (CI roof and walls, concrete floor)
6. Shed (CI roof with steel post external support; CI walls; concrete floor) and Meatroom (CI roof [lost], mesh and CI walls; wooden and metal post frame; CI to dado; concrete floor)

7. Late 20th century demountable residence (metal roof, fibro panel walls)
8. Shed (CI roof and walls; wooden and metal post frame; concrete floor; partially enclosed verandah to N and W)

9. Late 20th century demountable residence (metal roof, faux weatherboard walls)
10. Residence (modern)
11. Meatshed
12. Shed (Possible used as stable: CI roof and walls; metal post and railway rail frame; roof sheets attached with fencing wire to plate; concrete floor) adjacent to horse yard

13. Shed (CI skillion roof; CI walls) and cattle drafting yards
14. Original shearing shed (converted to garage and storage shed: CI roof and walls; iron water pipes and timber as frame; concrete and earth floor). Shearing pens in SE corner.

15. Garage and shed (CI roof and walls; concrete floor)
16. Site of sheep yards

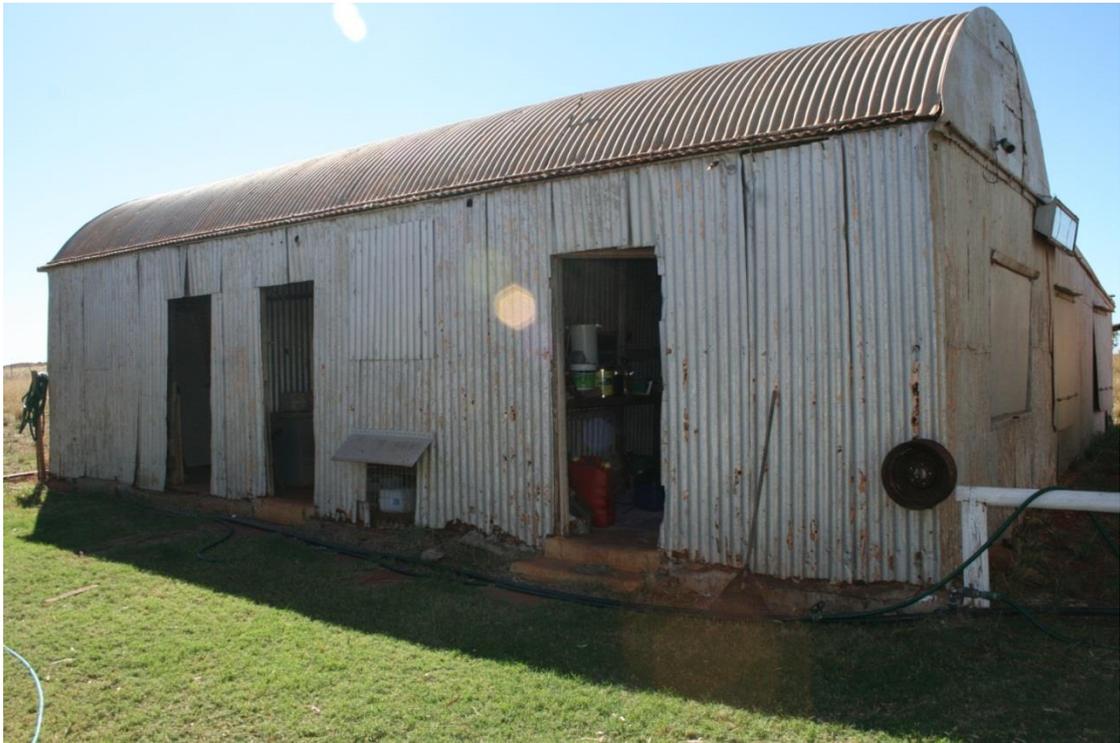
**Cookhouse, Mess and Original Store 2012**
